Errata sheet LPC4370, LPC4350, LPC4330, LPC4320, LPC4310

Rev. 6 — 21 October 2013

Errata sheet

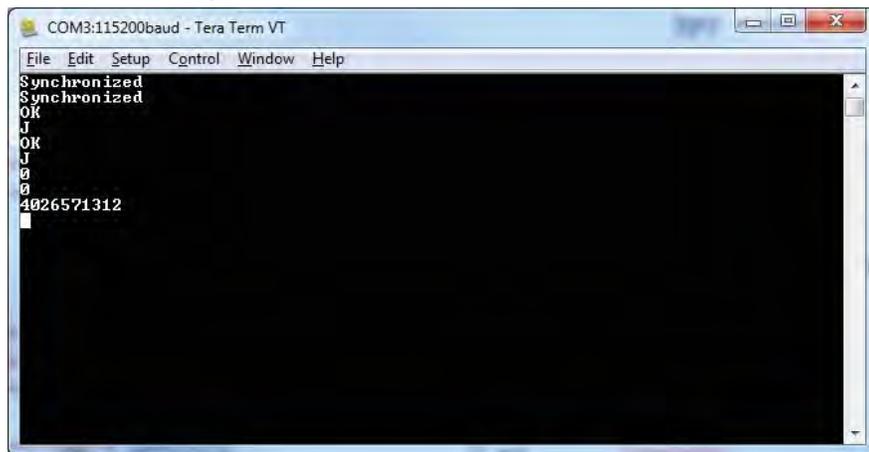
Incorrect example:

The 'J' command in ISP mode should return an error code, followed by an ASCII string representation of the part ID, followed by a 0. However what is actually returned is the error code, followed by a 0, followed by an ASCII string representation of the part ID. The problem is the last two items returned are swapped.

There is no work-around for this problem.

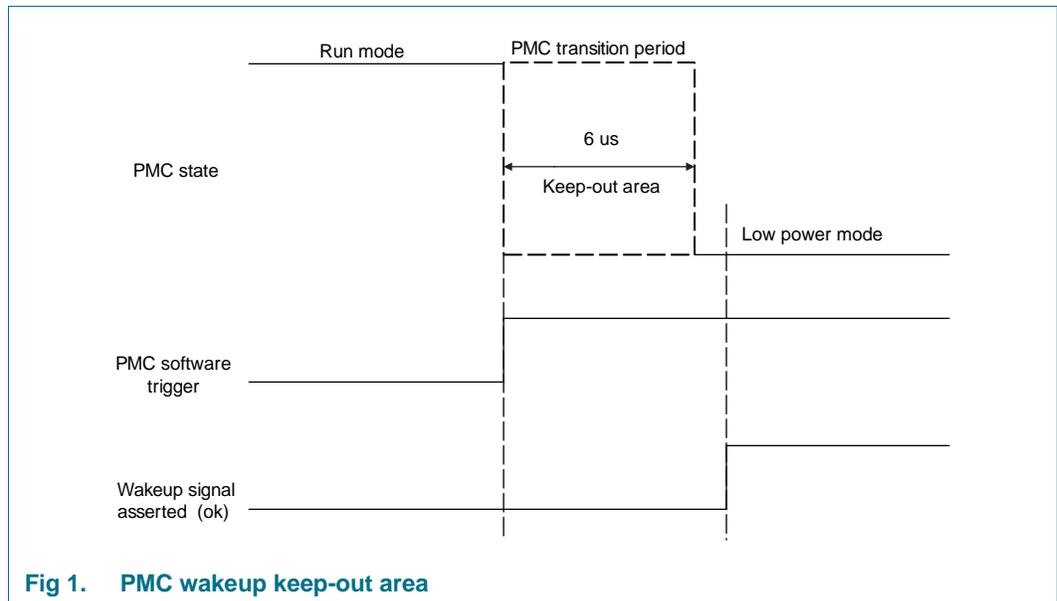
When the chip is in a transition from active to Deep Sleep, Power Down, or Deep Power Down, wakeup events are not captured and they will block further wakeup events from propagating. The time window for this transition is 6 uS and is not affected by the chip clock speed. After a wakeup event is received during the PMC transition, the chip can only recover by using an external hardware reset or by cycling power.

Make sure that a wakeup signal is not received during the Deep Sleep, Power Down, or Deep Power Down transition period. An example circuit to work around this could include an external 6 uS one shot which could be triggered via software using a GPIO line when entering Deep Sleep, Power Down, or Deep Power Down mode. The one-shot's output could be used to gate the wakeup signal(s) to prevent receiving a wakeup signal during the PMC transition period. Depending on the system design, it may also be needed to latch the wakeup signal(s) so that they will still be present after the one-shot's 6 uS timeout.

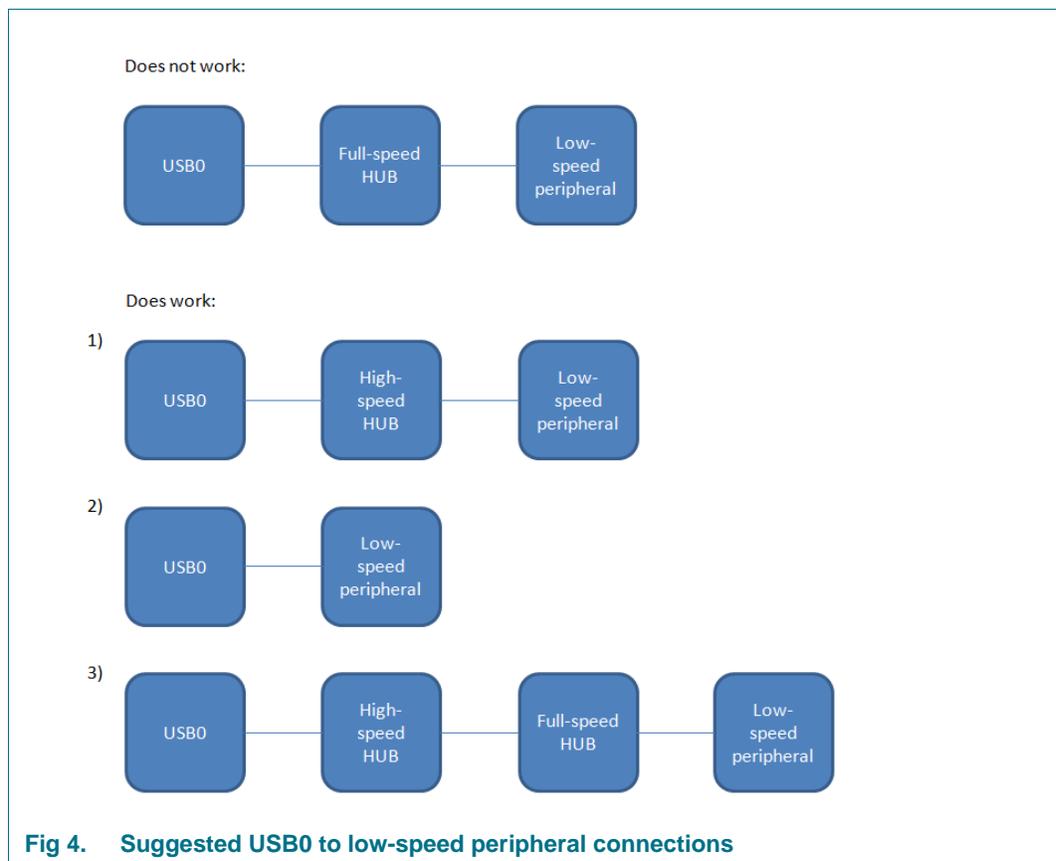
Fig 4. Suggested USB0 to low-speed peripheral connections

The USB controller called USB0 is unable to communicate with a low-speed USB peripheral in host mode when there is a full-speed hub directly connected to the USB0 port and a low-speed peripheral is connected in the tree somewhere below this full-speed hub. Only USB0 has this problem; the other USB controller, USB1 does not.

There is no work-around for this problem. It is suggested that the low-speed USB peripheral is either connected directly to USB0 or a high-speed hub is placed between that peripheral and USB0.
