Silicon identification

This errata sheet applies to the revision “Y”, “X”, and “1” of STMicroelectronics STM32F205xx/STM32F207xx and STM32F215xx/STM32F217xx microcontroller families. In this document they will be referred to as Root part number 1 and Root part number 2, respectively, unless otherwise specified.

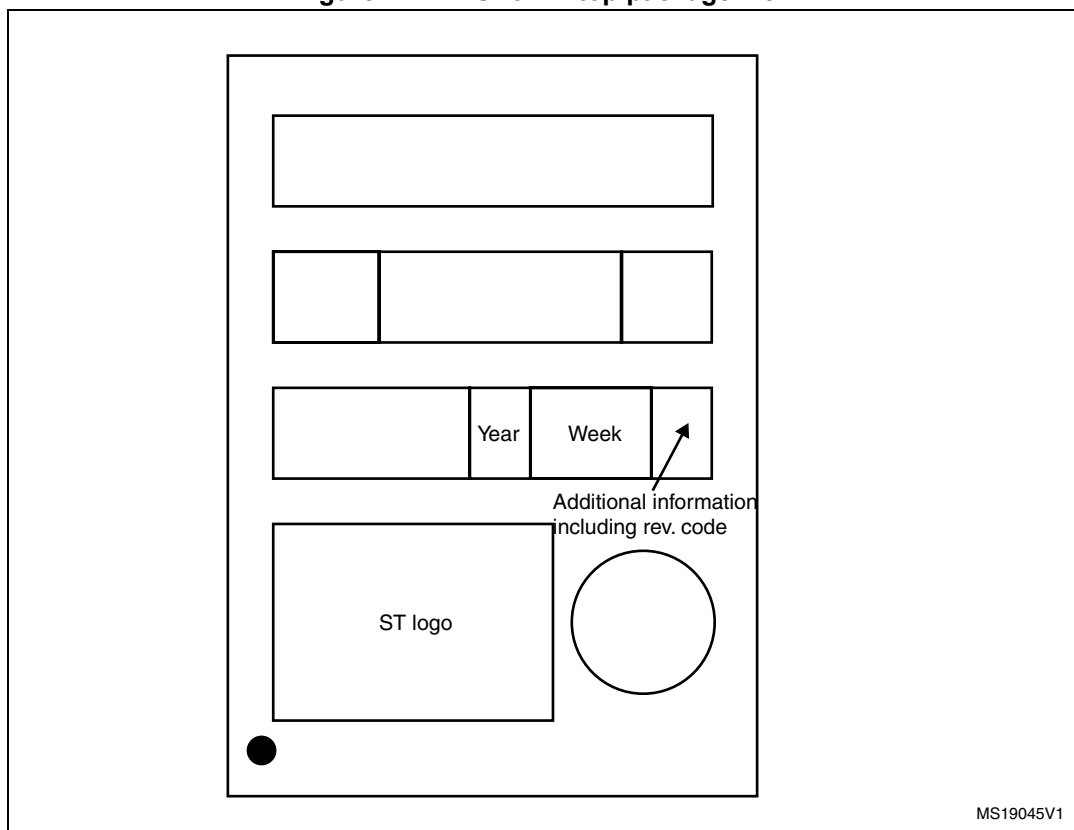
Figure 1. WLCSP64+2 top package view

[Figure 1](#), [Figure 2](#), [Figure 3](#), [Figure 4](#), [Figure 5](#) and [Figure 6](#) show the marking compositions for the WLCSP64+2, UFBGA176, LQFP176, LQFP144, LQFP100 and LQFP64 packages, respectively. The only fields shown are the Additional field containing the revision code and the Year and Week fields making up the date code.

1. The REV_ID bits in the DBGMCU_IDCODE register show the revision code of the device (see the STM32F20x and STM32F21x reference manual for details on how to find the revision code).
2. Refer to [Appendix A: Revision code on device marking](#) for details on how to identify the revision code and the date code on the different packages.
